Safety Inspection Report

Annual Inspection

Cantley Village Hall, NR13 3RT

07 October 2024

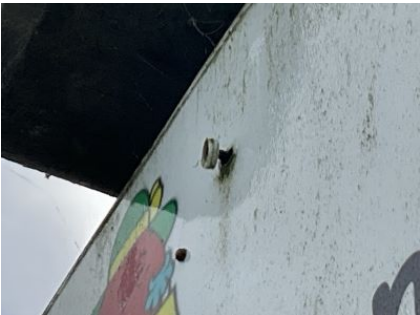
Description
Item is not secure.
Tasks
Secure.
Note
The sign attached to the toddle swing is loose. Secure correctly.

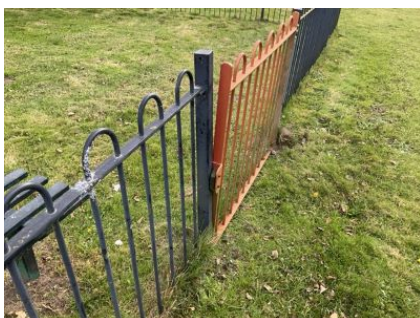
The supports are loose in the ground.

Gate slam post is leaning. Consider resetting level.

Re-set.

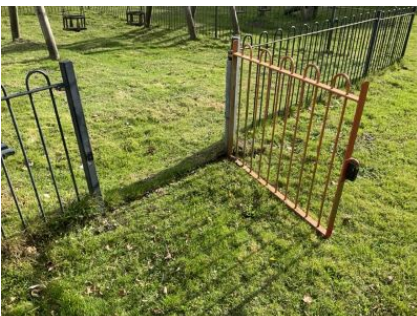
Gate is sticking on the ground.

Adjust.

Alter grass level.

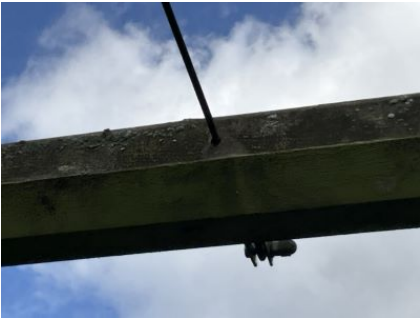
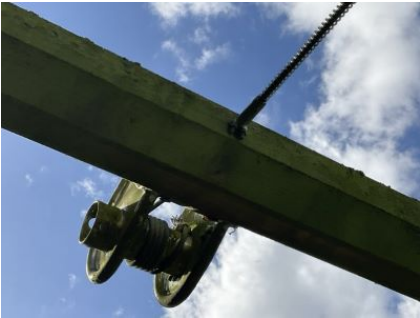
Cables have been known to fail under load due to wear and corrosion. This is generally where the cable enters into a tube, top bar, sleeve or similar, where the wire is in contact and wears and frays over time, but can happen anywhere on the cable. It is important to inspect any hidden parts at least annually. Damaged cables require replacement. This cannot be determined during an annual inspection, and is excluded from our inspection. This can lead to a high risk if no action is taken. Refer to the manufacturer's instructions to ensure the correct check is carried out.

Conduct an appropriate dismantling inspection according to the manufacturer's instructions, and at least annually. The trolley mechanism can be checked at the same time.

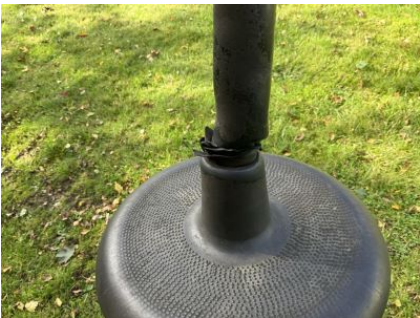
Item is damaged.

Chain cover has bin cut around the seat area which could pinch or cut a users legs/skin. Replace.

Read the notes for further action., Replace.

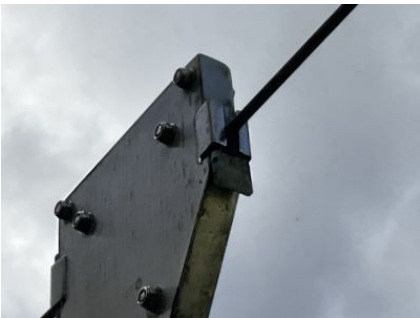
Item is worn.

Trolleys plastic cable guard is worn. Replace x 1.

Replace.

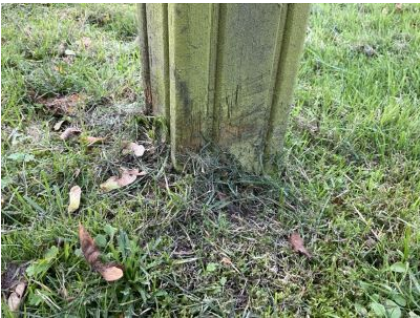
Strimmer damage is present on posts, allowing water to enter and timbers to soften. It can also remove the protective envelope around the timber. Prevent further damage and check timbers for decay throughout the year.

Prevent further damage.

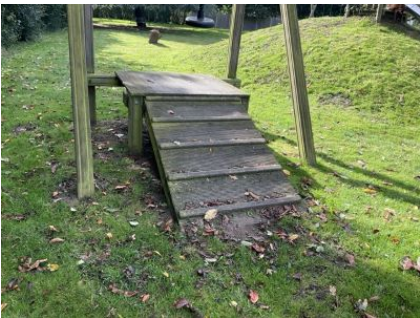
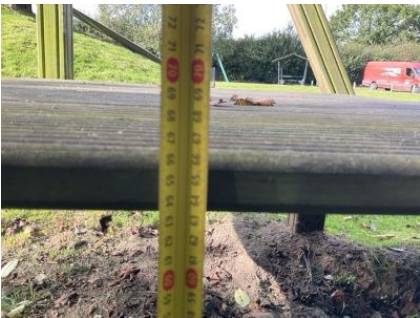
The equipment is easily accessible, has a free height of fall exceeding 600 mm, but does not have barriers to the standing surface.

The platform is above 600 mm and is easily accessible via the ramp. Our inspector recommend the ground around the platform is built up to reduce the ground clearance.

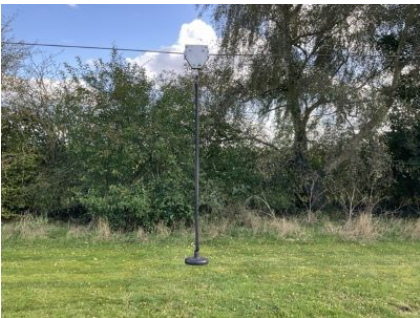
It is considered that the runway will have insufficient ground clearance under seat.

When fully loaded the seat height is low.

Modify to give a minimum 350 mm clearance under load.

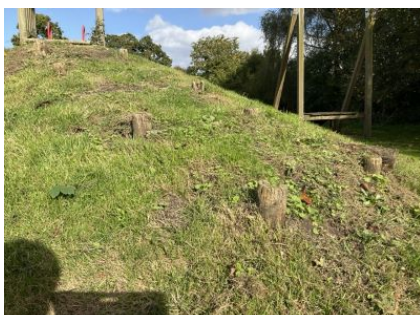
Trip points on the surface.

Several posts project from the ground to the rear of the slide platform. Remove as these create potential trip points.

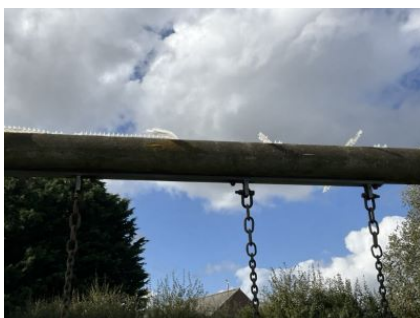
Item has some parts missing.

Anti bird device loose and missing from the top bar. Replace and secure.

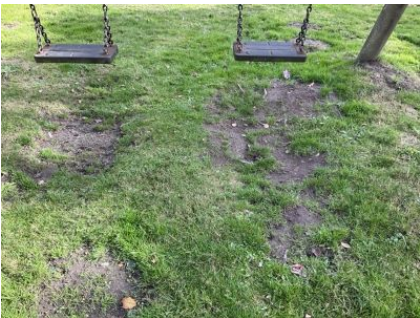
Surface is uneven.

The grass mats are buried in the ground and the soil area is uneven. Consider levelling out the ground and replacing the grass mats.

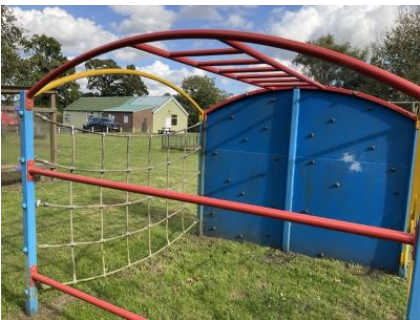
RoSPA is concerned by accidents on some types of overhead ladders and rings. However, there is a strong development value in these items.

The protective surface under all bars and rings must be kept in good condition.

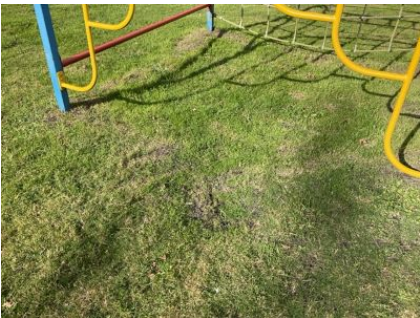
Surface is uneven.

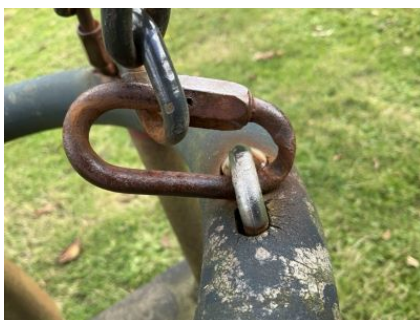
Chain link connectors worn.

Replace worn parts.

Replace connectors x 8.

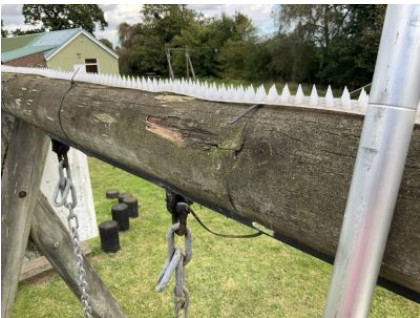
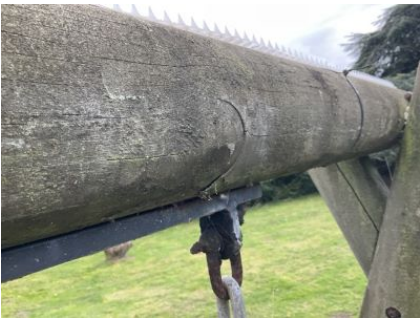
Top bar is showing signs of wear and splitting. Monitor for decay throughout the year and replace if found.

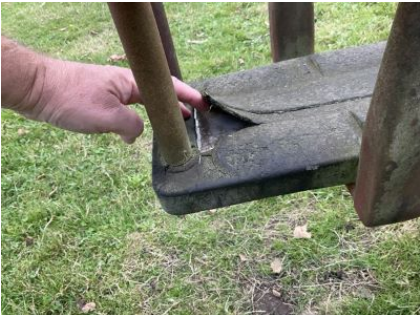
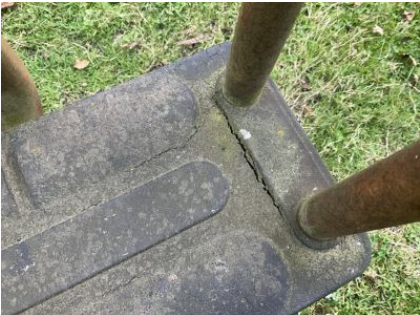
Swing seat rubber is deteriorating / degrading.

Replace.

Replace both cradle seats.

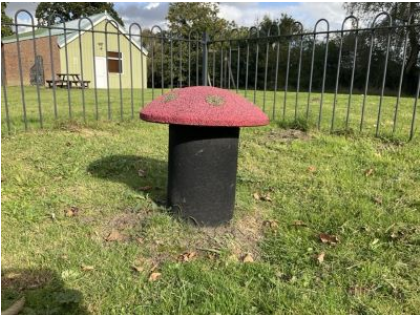
Slight excess movement in the bearings. Replace when necessar.

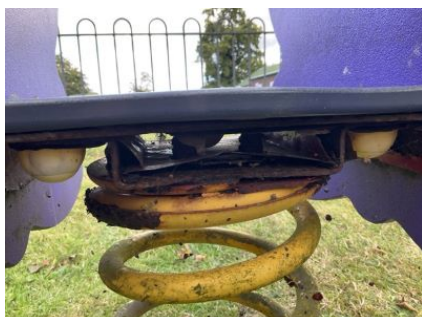
Paintwork is in poor condition.

Metalwork has started to rust.

De-scale back to good base material and coat with lead free paint, using appropriate precautions. Repairs may be necessary where corrosion is severe.

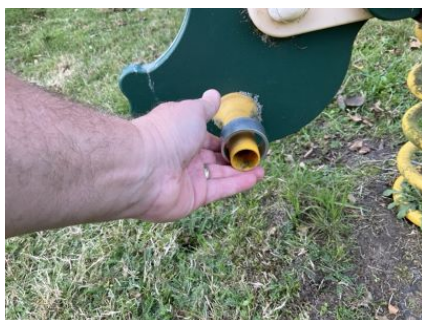
Item has some parts missing.

Ball caps missing from the footrests creating a ring gauge failure replace caps x 2.

Replace the missing parts.

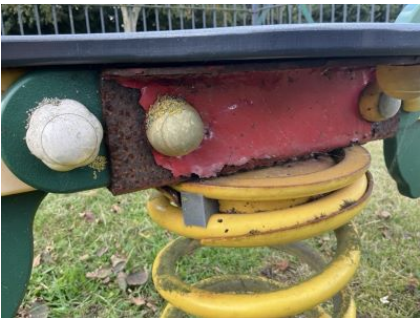
Paintwork is in poor condition.

Metalwork has started to rust.

De-scale back to good base material and coat with lead free paint, using appropriate precautions. Repairs may be necessary where corrosion is severe.
