Safety Inspection Report

Annual Inspection

Cantley Village Hall, NR13 3RT

07 October 2024

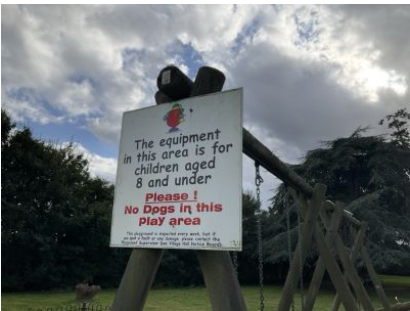
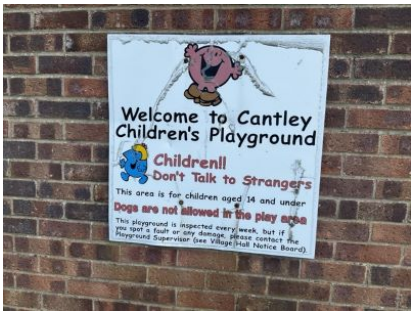
Signage - Ownership

Description
Item is not secure.
Tasks
Secure.
Note
The sign attached to the toddle swing is loose. Secure correctly.

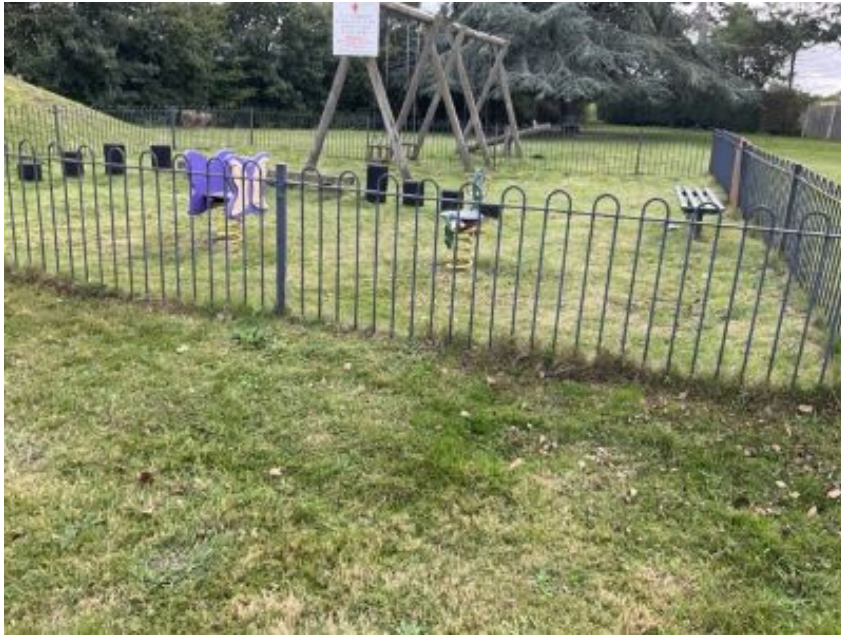
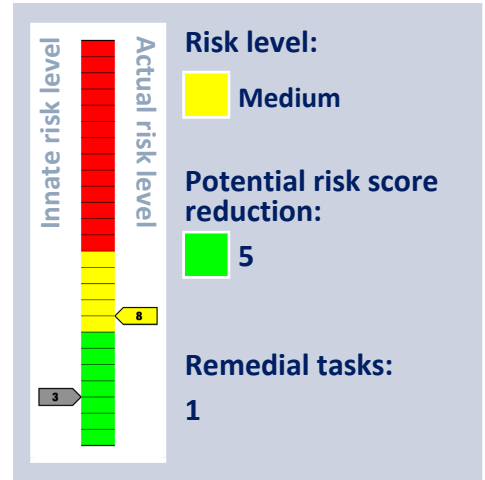
Fencing - Bow-Top

The supports are loose in the ground.

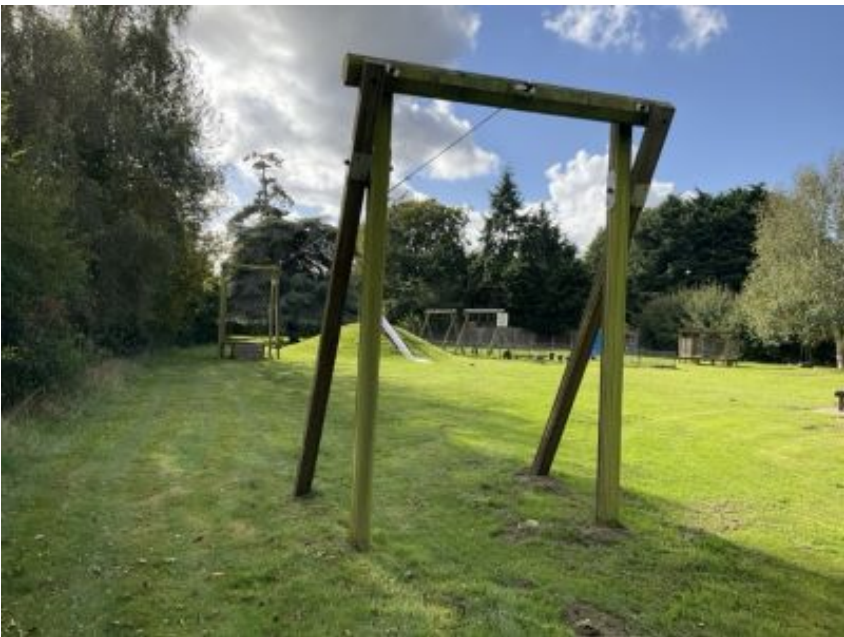
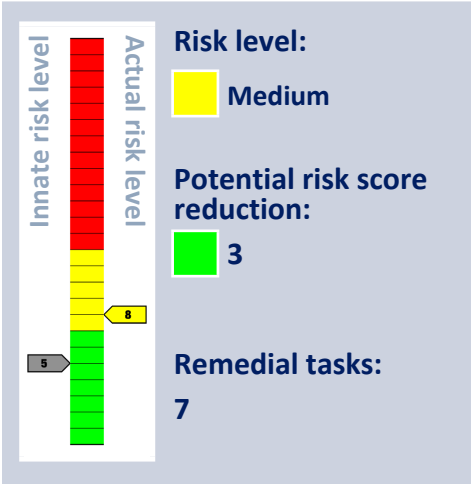
Cableway - Seated

The item is not compliant with the requirements of the relevant standards. The surfacing meets with the requirements of the relevant standards.

Cables have been known to fail under load due to wear and corrosion. This is generally where the cable enters into a tube, top bar, sleeve or similar, where the wire is in contact and wears and frays over time, but can happen anywhere on the cable. It is important to inspect any hidden parts at least annually. Damaged cables require replacement. This cannot be determined during an annual inspection, and is excluded from our inspection. This can lead to a high risk if no action is taken. Refer to the manufacturer's instructions to ensure the correct check is carried out.

Item is damaged.

Chain cover has bin cut around the seat area which could pinch or cut a users legs/skin. Replace.

Item is worn.

Trolleys plastic cable guard is worn. Replace x 1.

Read the notes for further action., Replace.

Replace.

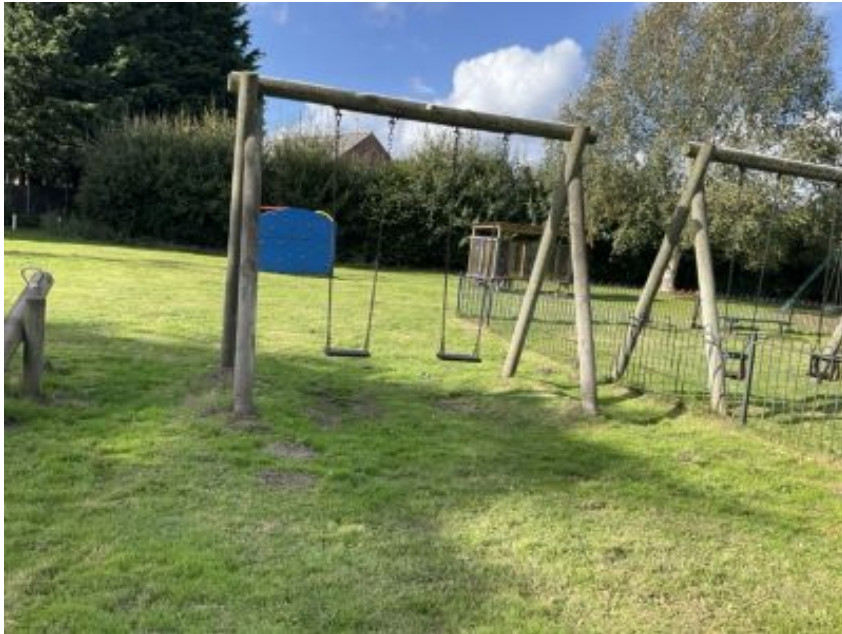
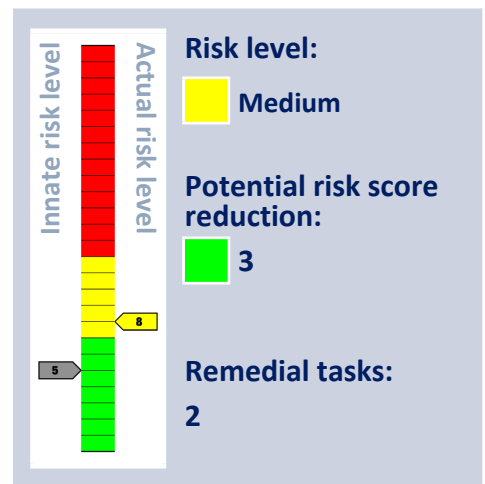
Swing - Junior - 1 Bay 2 Seat

Item has some parts missing.

Anti bird device loose and missing from the top bar. Replace and secure.

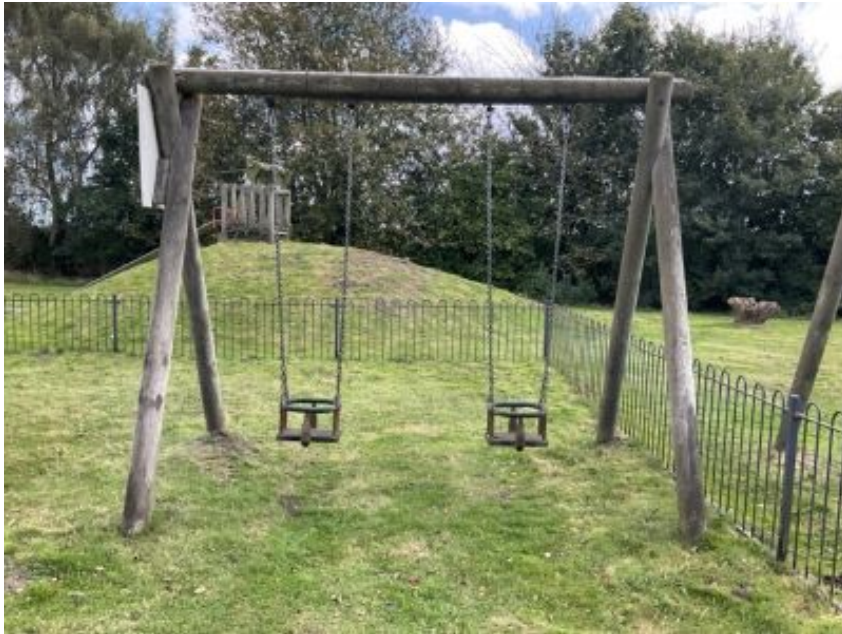
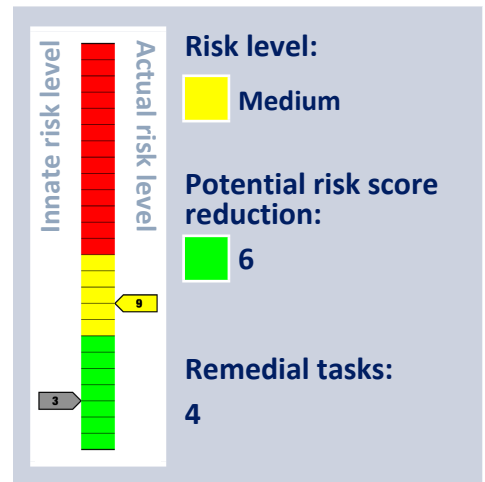
Swing - Toddler - 1 Bay 2 Seat

Chain link connectors worn.

Replace connectors x 8.

Top bar is showing signs of wear and splitting. Monitor for decay throughout the year and replace if found.

Replace worn parts.

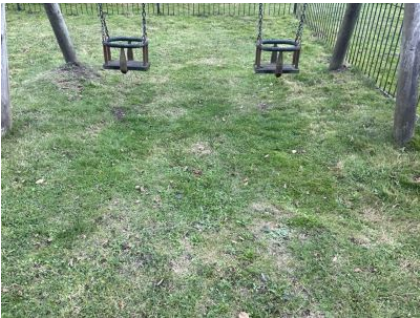
Swing seat rubber is deteriorating / degrading.

Replace both cradle seats.

Replace.

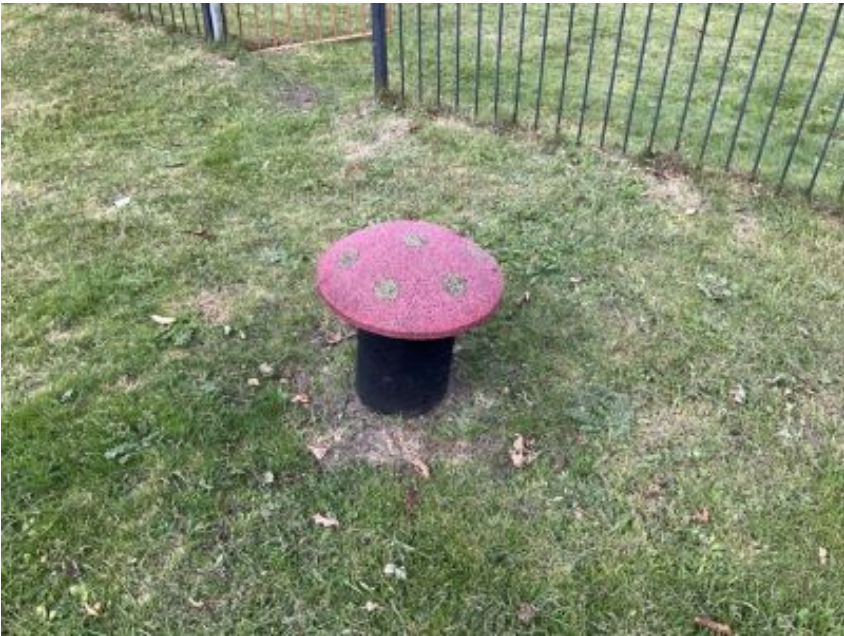
Carousel - Mushroom (Less Than 500 mm Diameter)

Slight excess movement in the bearings. Replace when necessar.

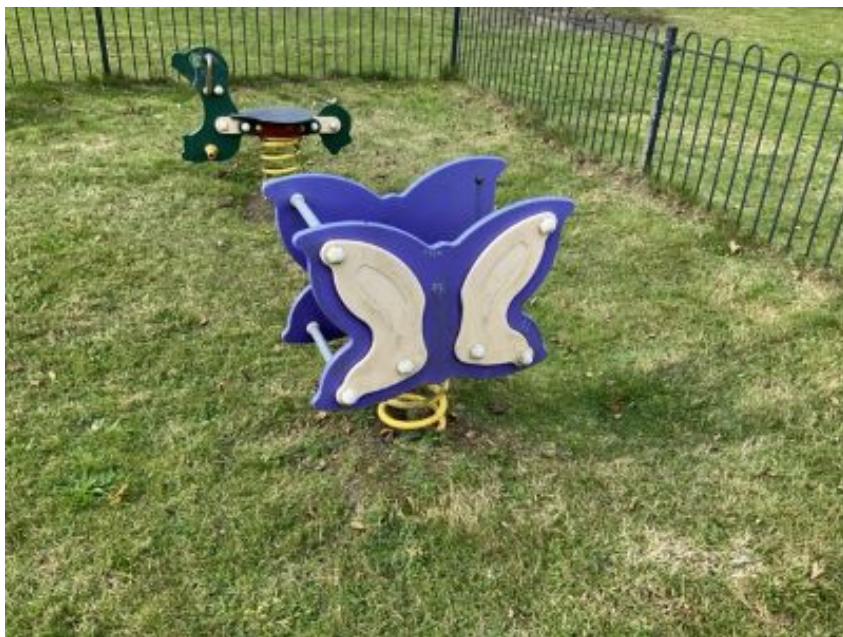
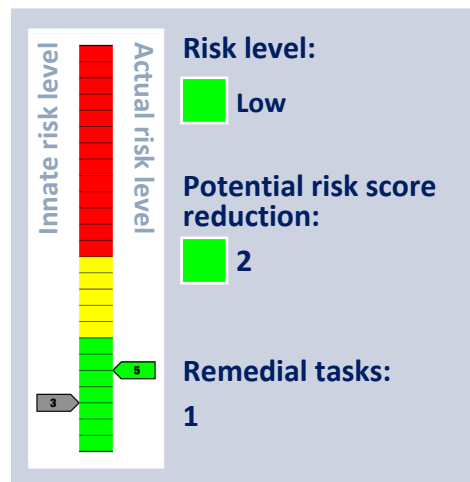
Rocker - Butterfly

Paintwork is in poor condition.

Metalwork has started to rust.

De-scale back to good base material and coat with lead free paint, using appropriate precautions. Repairs may be necessary where corrosion is severe.

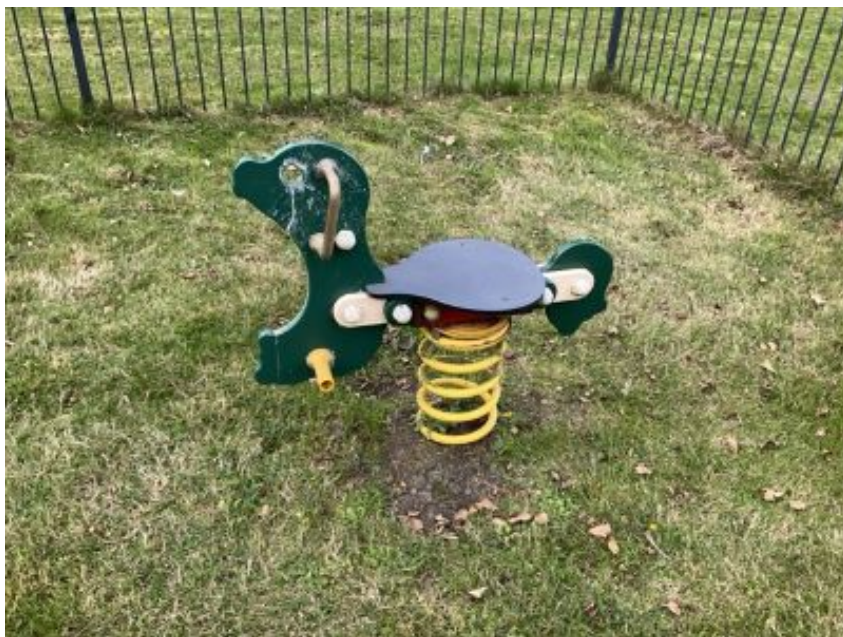
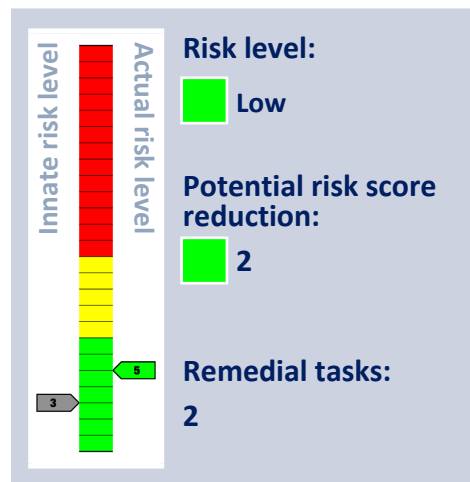
Rocker - Seal

Item has some parts missing.

Ball caps missing from the footrests creating a ring gauge failure replace caps x 2.

Paintwork is in poor condition.

Metalwork has started to rust.

Replace the missing parts.

De-scale back to good base material and coat with lead free paint, using appropriate precautions. Repairs may be necessary where corrosion is severe.
